Experimental study on fallout behaviour of tempered glass façades with different frame insulation conditions in an enclosure fire

Wang, Y, Sun, J, He, L, Wang, Q & Rush, D 2018, 'Experimental study on fallout behaviour of tempered glass façades with different frame insulation conditions in an enclosure fire', *Proceedings of the Combustion Institute*. <https://doi.org/10.1016/j.proci.2018.07.111>

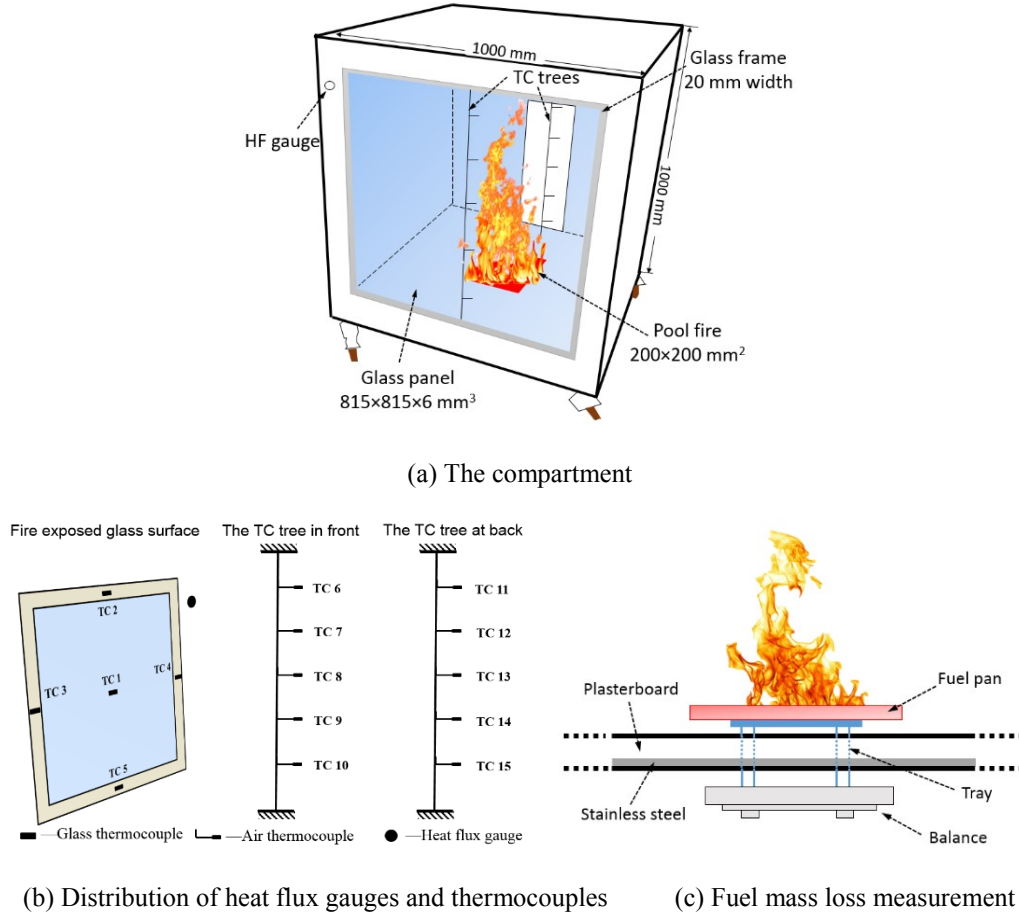
Fig. 1. The schematic of compartment used for the experimental tests.

Fig. 1. The schematic of compartment used for the experimental tests. (a) The compartment; (b) Distribution of heat flux gauges and thermocouples; (c) Fuel mass loss measurement.

A compartment with an external dimension of $1000 \times 1000 \times 1000 \text{ mm}^3$ was built to resemble the fire conditions in glass façade furnished buildings, as shown in Fig. 1(a). In the compartment model, one face of the wall is totally glass and its opposite side is a door which is to resemble the office in the high-rise buildings. The walls of this enclosure were constructed of 5 mm stainless steel lined with 20 mm-thick plasterboards. To the authors' knowledge and survey, an estimated range of glass façade panel dimension is from $300 \times 300 \text{ mm}^2$ to $6000 \times 6000 \text{ mm}^2$, tempered glass panels of $815 \times 815 \text{ mm}^2$, 6 mm thick, were installed into the front wall in the present work. The glass frame was made of 1 mm thick stainless steel and capable of installing glass panels with different thicknesses. Stainless steel was selected due to its relatively stable behavior in fire compare with other frame materials, such as aluminium extrusion, timber or plastic. In each test, the pressure from frame to the glass in the thickness direction was controlled by four screws. Since the maximum expansion, less than 1 mm, is smaller than the normal gap of several mm between the frame and the glass panel [4, 19], no in-plane restraint from the frame existed in the experiments, thus simulating realistic conditions as closely as possible. In addition, a ventilation opening of $200 \times 1000 \text{ mm}^2$ was incorporated into the back wall of the compartment and a pool fire with a dimension of $200 \times 200 \text{ mm}^2$ was positioned at the center of the compartment. The opening factor of the compartment was 0.033 and is representative of an office the

The measurement systems included the sheet and sheathed thermocouples (TCs), heat flux (HF) gauge, mass loss balance, digital camera and data acquisition. The sheet thermocouples were attached to the glass panes to detect the surface temperature via their high heat-conducting sheets, which is made of aluminium alloy with a high heat conductivity of $226 \text{ W/m}\cdot\text{K}$. The dimension of sheets is approximately $25 \times 15 \text{ mm}^2$, thus it can increase the contact areas between detected objects and a temperature-sensing element. Two TC trees, 30 mm away respectively from the glass wall and back wall, were positioned at the center line of the compartment, as shown in Fig. 1(a). In each tree, five

sheathed thermocouples were fixed equidistantly (158 mm) to measure the gas temperature. Meanwhile, five sheet thermocouples were employed to record the glass surface temperatures at the fire side: four TCs were attached in covered areas and only one at the center of the fire-exposed surface. It should be noted that both sheathed and sheet TCs were K-Type thermocouples with a measurement range of 0-1200 °C and sensitivity of 41 mV/°C. The uncertainty of TCs was estimated at 10-20% [20].

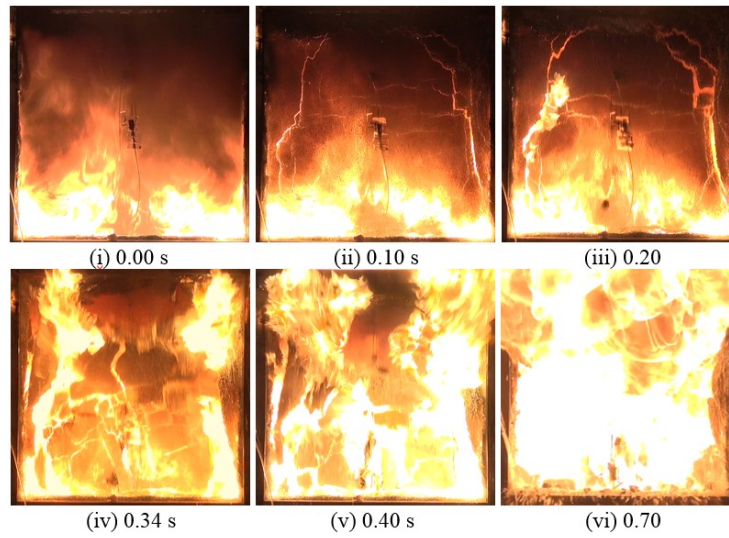
(a) Breakage and fall out

Fig. 2. The process of glass fallout and flame spread in Test 3.

Fig. 2. The process of glass fallout and flame spread in Test 3. (a) Breakage and fall out; (b) Side view of window-ejected flame (glass located at left side)

Fallout of the tempered glass, if critical breakage conditions were satisfied and cracks initiated, occurred very quickly. As an example, the failure of Test 3 is shown in Fig. 2(a). The process only took 0.70 seconds from the crack initiation to complete fallout. It appears that two primary cracks initiated from the top edge of the glass panel and dominated the first 0.2 seconds of breaking. Once the glass had started to fall out, the fallout of the glass allowed a portion of the ejected fuel vapours to ignite outside the compartment. Meanwhile, the whole glass panel broke into a large number of small pieces and started to fall out. This phenomenon occurred in other tests as well. The crack initiation and

propagation process at the very beginning were similar to that of float glass, however, more “islands” could be formed in tempered glazing which renders it much easier to fall out.

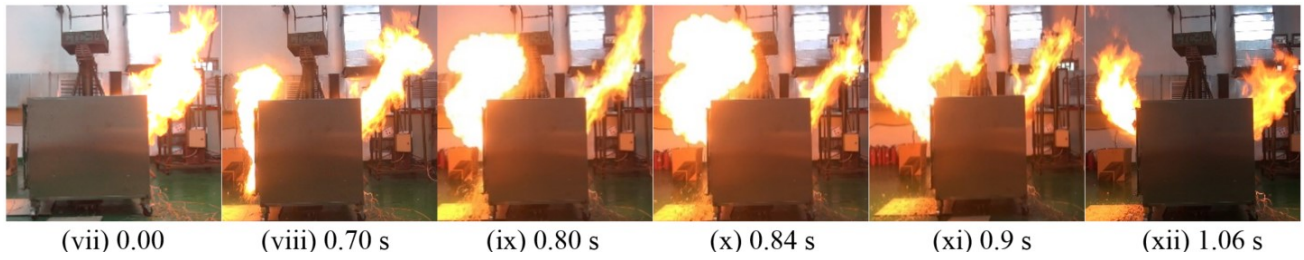
(b) Side view of window-ejected flame (glass located at left side)

Fig. 2(b) demonstrates the ejected flames after the glass completely fell out. The glass fallout affects the ventilation to the compartment which in turn affects the fire dynamics both to the interior and exterior of the compartment. At the front side, the flame with large momentum spread quickly in both horizontal and vertical directions, with the largest visible flame height of 2.1 m above the glass top edge and the largest horizontal distance of 0.7 m from the glass surface. A scale ruler software was used to measure the visible flame dimension in video and pictures using the compartment size as a reference. In the other tests, the ejected flame heights were all above 2.0 m. After 0.36 s, the burning went back to the new stable status again. The ventilation-controlled fire in the fully developed stage switches to a fuel-controlled fire due to glass fallout. Because of the significant effect of glass fallout, we can define the compartment fire development as pre-fallout and post-fallout stages. The effect of ventilation changes on the critical fallout parameters is discussed in the following section.

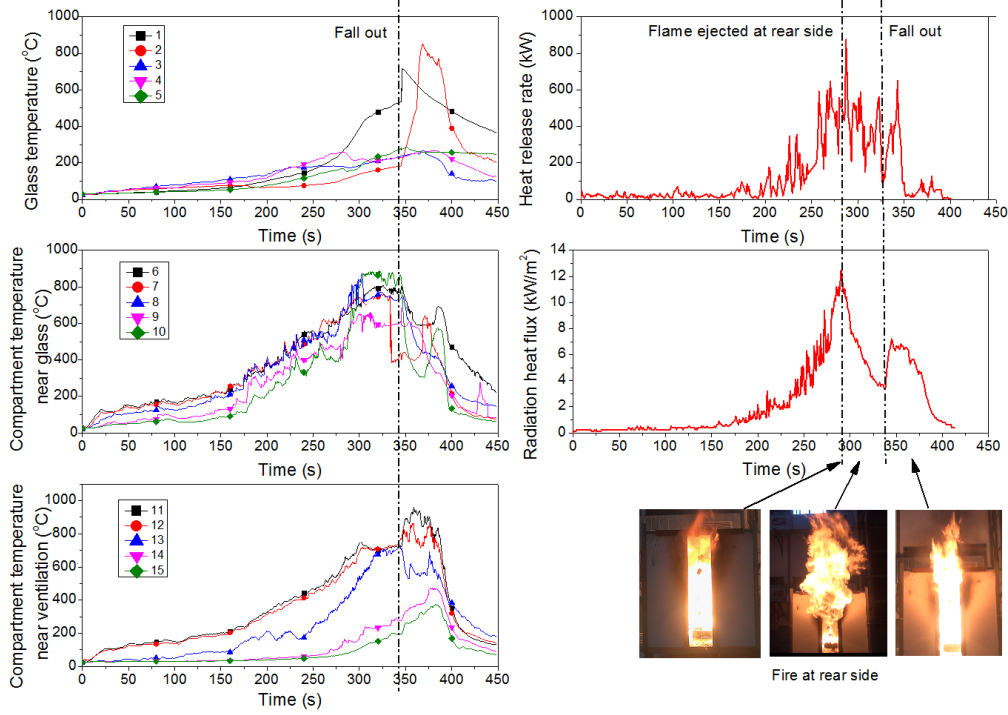
Fig. 3. The temporal evolution of the parameters in Test 3.

To investigate the influence and proportion of different sources of heat flux, both the imposed radiation heat flux from the flame (in Test 3) and total heat flux from the flame and the smoke (radiation,

convection, conduction in the remaining tests) were recorded and compared. The parameters in Test 3 are shown in Fig. 3. According to HRR variance, the flashover occurred at around 250 s. From T_{11} - T_{15} , the height of neutral plane decreased gradually until the glass fallout, which can be explained simply but the ideal gas equation: the gas density decreased with the increase of temperature. In addition, the following equation can directly estimate the phenomenon [25]:

where h_N and H_o are the neutral plane height and vent height; T_g and ρ_g are enclosure gas temperature and density; ρ_a is the density of air outside the room. Moreover, the exposed glass surface temperature measured by TC1 started to increase much faster than the temperatures in covered areas at around 250 s and the glass fell out at 343 s. At the post-fallout stage, it was found that the T_6 - T_{10} were cooled down rapidly from 800 °C to 400 °C. Meanwhile, the T_{13} declined markedly, which indicates the neutral plane moved higher relative to the floor. The similar phenomena occurred in the other tests.

In HRR curve, it indicates a spike just after the flame ejection (291 s) occurs and is also volatile up until about 350 s. However, it did not change the HRR greatly which stabilized between 400-600 kW. With consideration of the noise in the compartment, this HRR is reasonable. Meanwhile, the incident radiation heat flux (front side) decreased by 60%, and then slightly increased due to the glass fallout. This change in heat flux suggests that the flame radiation, rather than the smoke radiation, dominated the imposed radiation received by the glass panel.

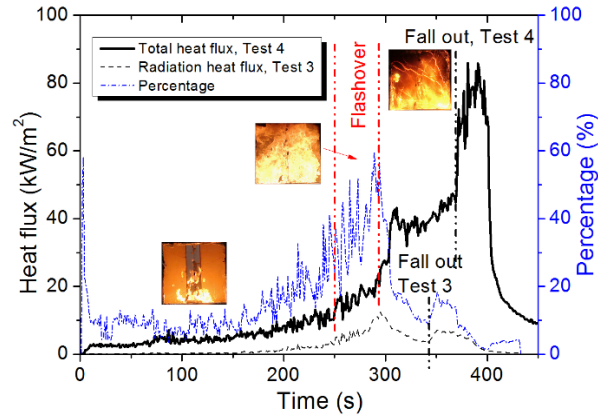
Fig. 4. The comparison of total heat flux and radiation heat flux.

The experimental conditions are assumed identical, and the comparison of imposed total and radiation heat fluxes is illustrated in Fig. 4. It was established that convective heat transfer usually accounts for more than 80% of the glass heating, except during the flashover phase where it is approximately 60%. The convective heat transfer is shown to be the primary heat exchange mechanism between the glass panel and the enclosure fire. This is markedly different from the glass heating in

open space where convective heat transfer accounts for less than 15% of the total heat exchanged [15]. The difference between free burning tests and compartment fire tests is primarily caused by the smoke or hot gases.

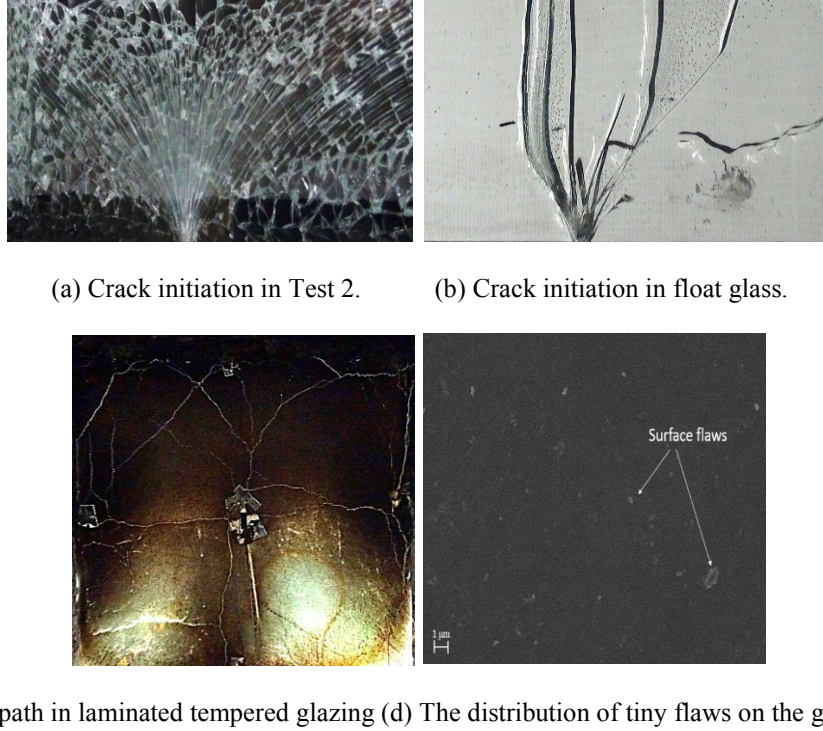
Fig. 5. Post cracks of tempered and float glass panels after heating.

Fig. 5. Post cracks of tempered and float glass panels after heating. (a) Crack initiation in Test 2; (b) Crack initiation in float glass; (c) Crack path in laminated tempered glazing; (d) The distribution of tiny flaws on the glass surface.

The fan-shaped cracking pattern at the edge of the tempered glass panel, as shown in Fig. 5(a), exists, similar to that which would be found in float glass (Fig. 5(b)). This implies overloading/overstressing of edge defects in both float and tempered glass can cause failure. The “primary” cracks in tempered glass ran at a very high speed before the whole glass panel disintegrates due to the release of the pre-stress energy [27]. To catch the “primary” cracks, one additional laminated tempered glass panel was tested under the identical condition Fig. 5(c). A scanning electron microscope was used to photograph the glass surface near the panel edge, as shown in Fig. 5(d). The evident crack path and numerous tiny flaws observed confirm that the dominant failure cause of tempered glass in fire is related to the tensile stress concentration near the flaws or defects at the glass panel edges.
